CITY OF
EL SEGUNDO

**REPAIR OF DISTRESSED WALLS
AND
SURFACES AT RECREATION PARK**

PW 25-05

General Overview

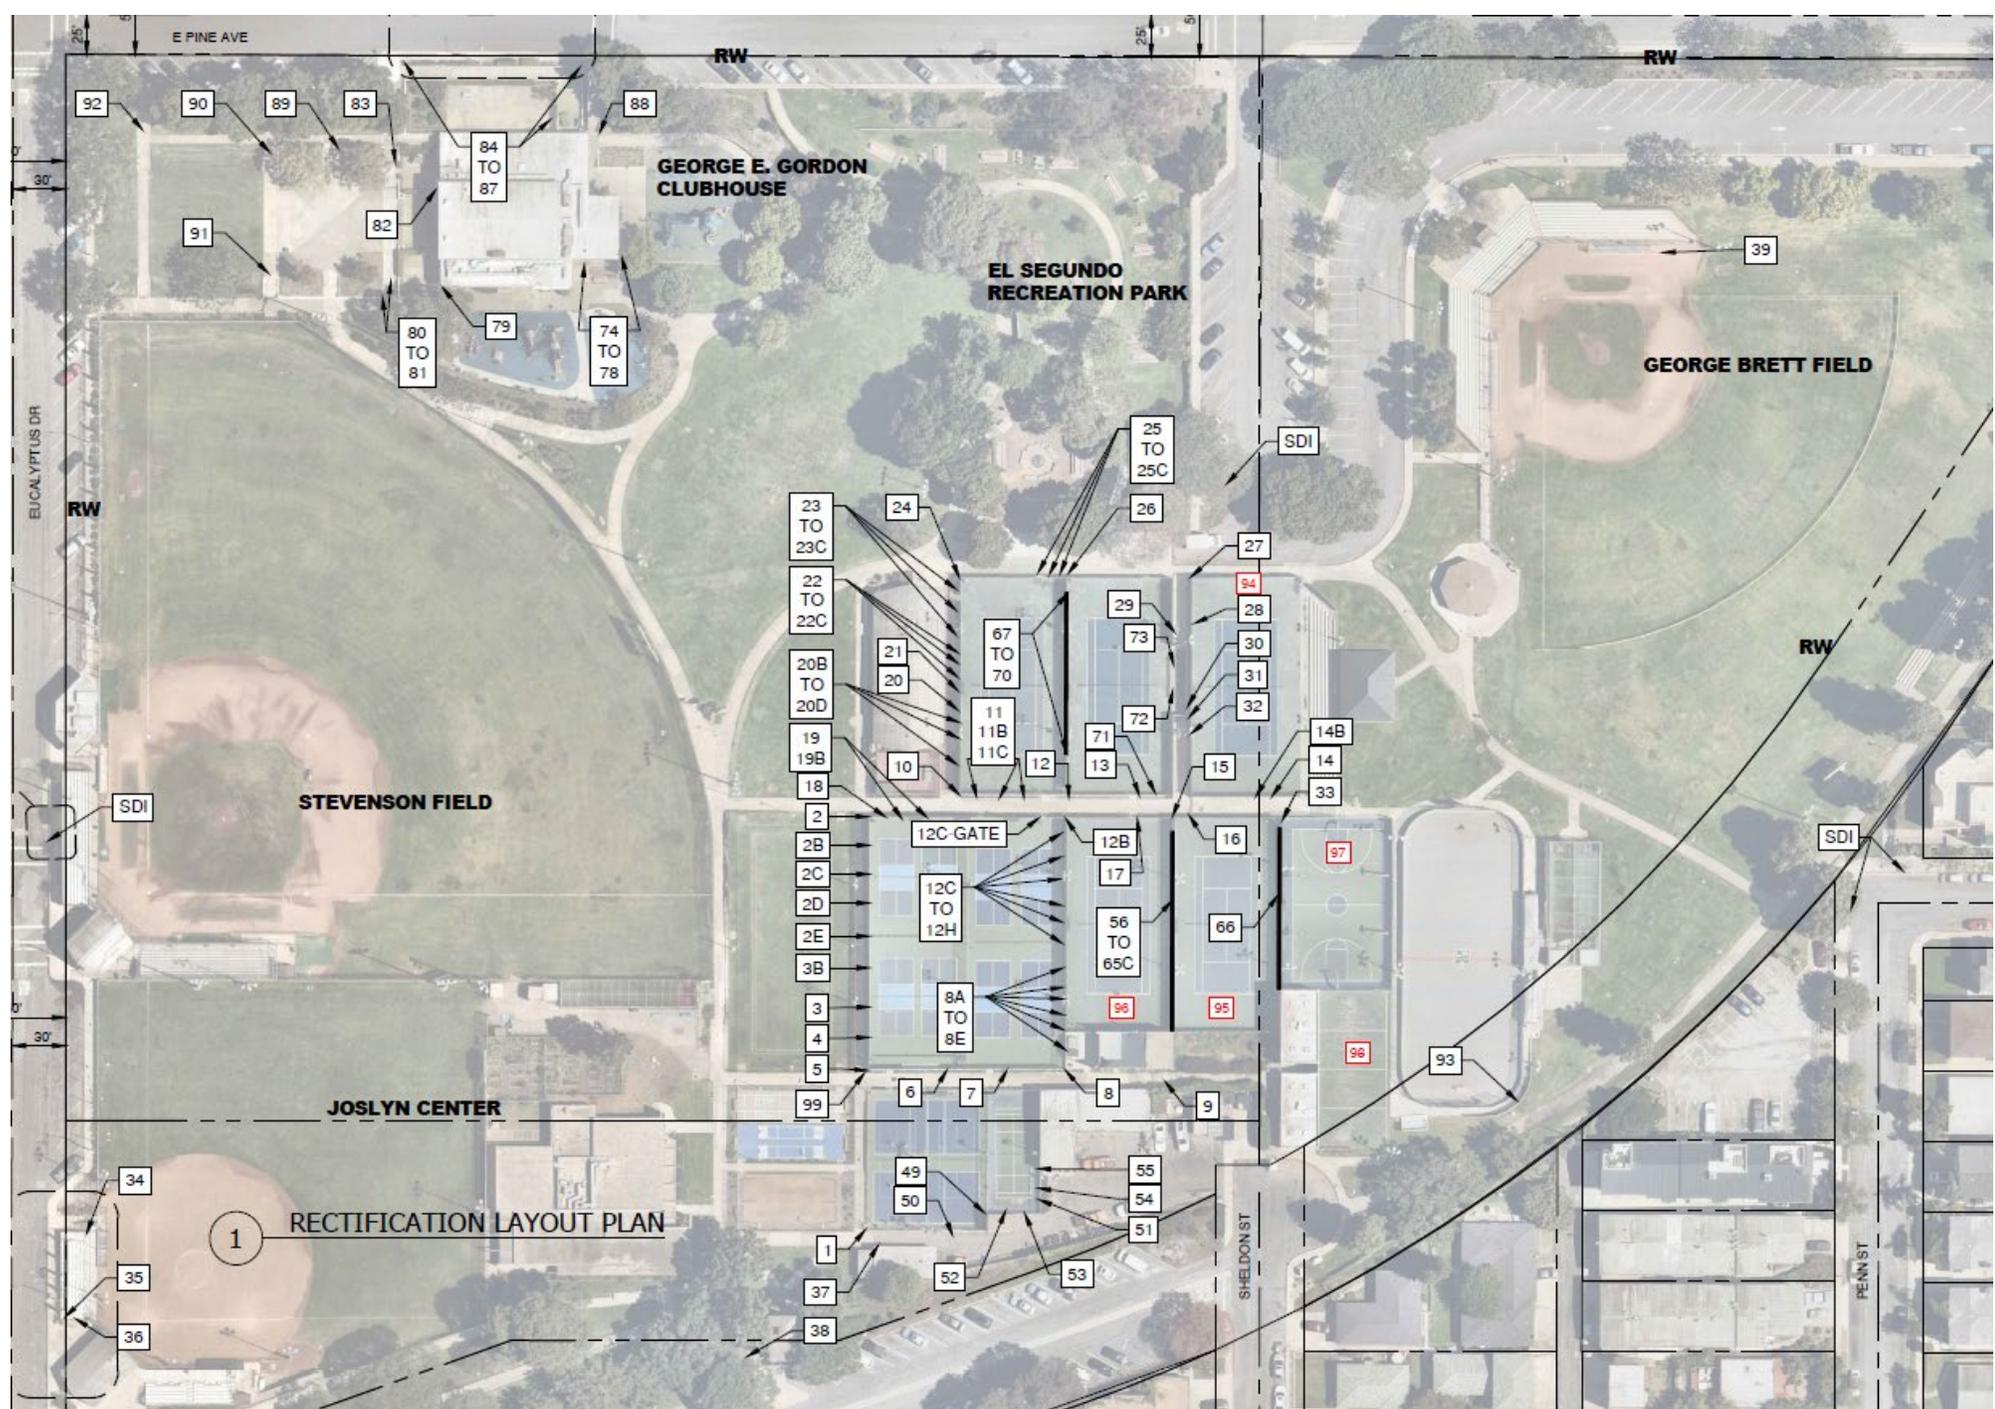
Location of Distress

1. 93+ repair locations across tennis, pickleball, paddleball, basketball, volleyball courts, bleachers, clubhouse areas, and stairways.
 - i. Work Includes: removal of damaged concrete, rebar repair, concrete replacement, and cosmetic crack and spall repair methods (epoxy, flood coat, & injection).
2. 50 Working days
3. Cost Estimate: \$950,000

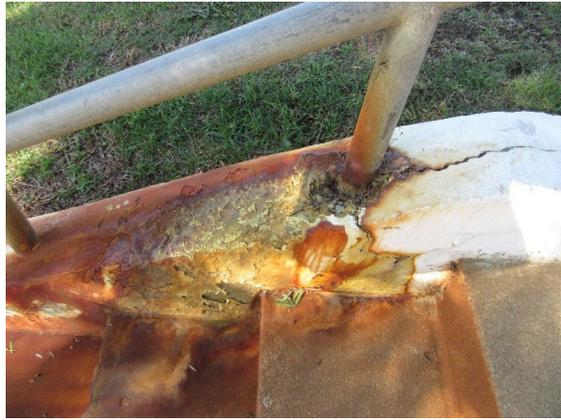
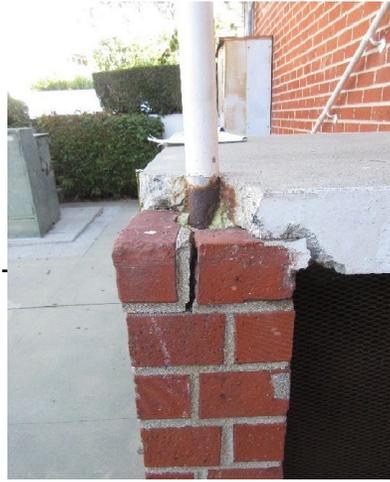
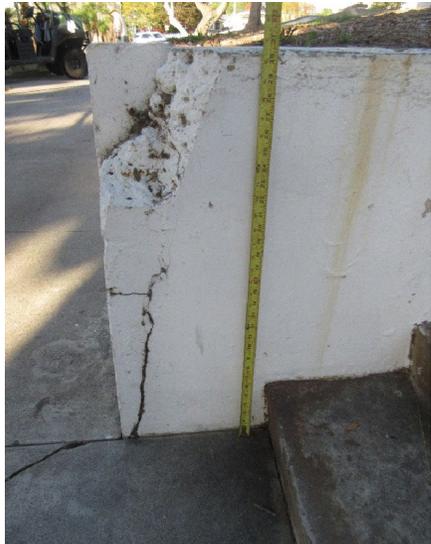
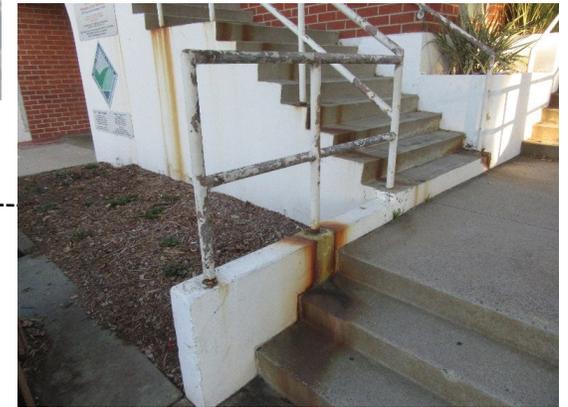
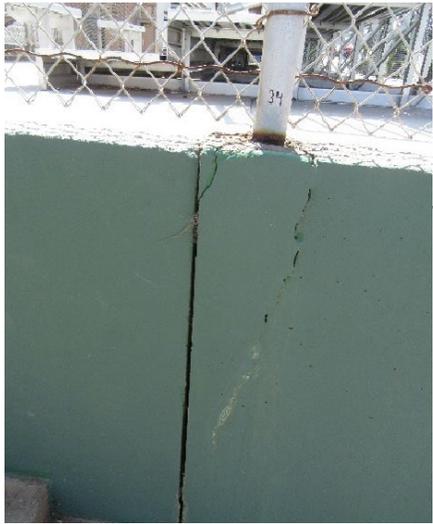
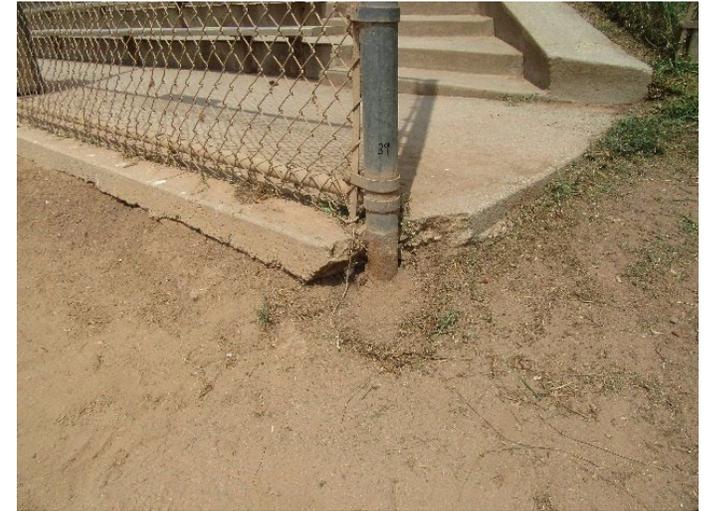
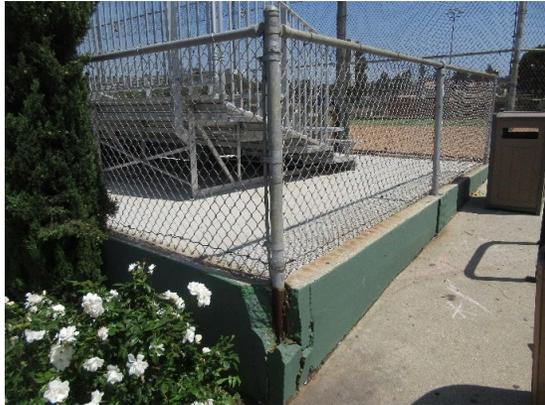
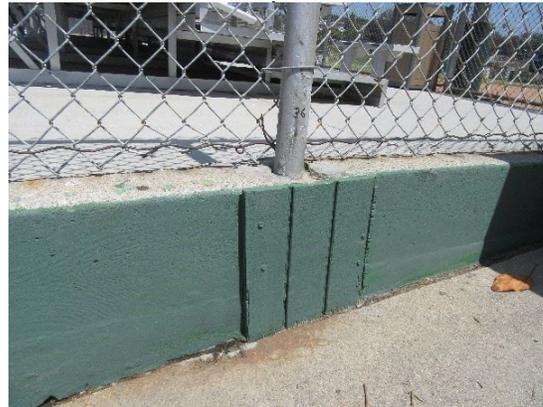
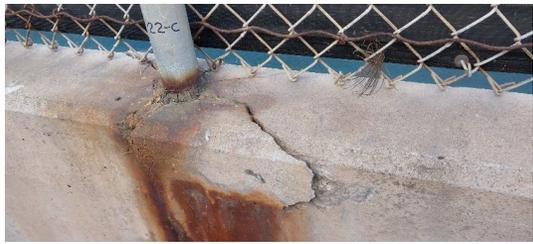
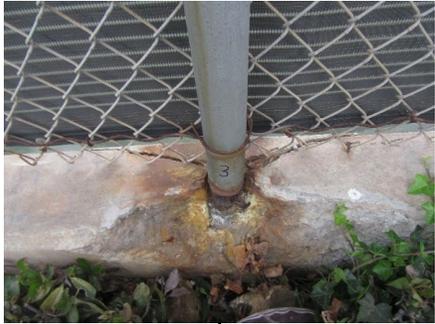
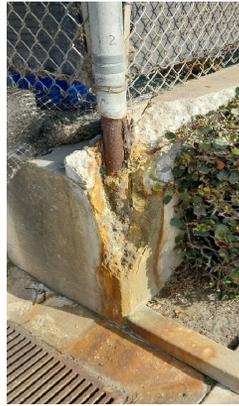
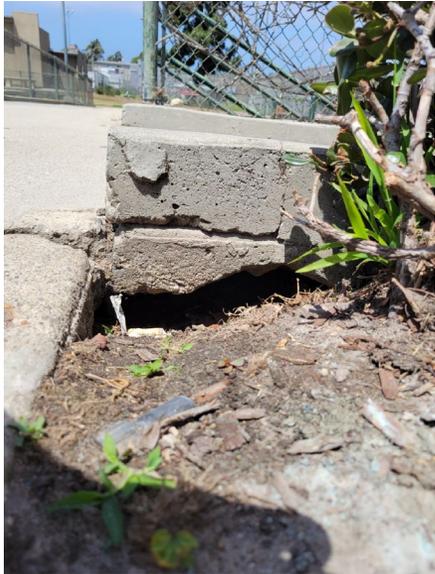
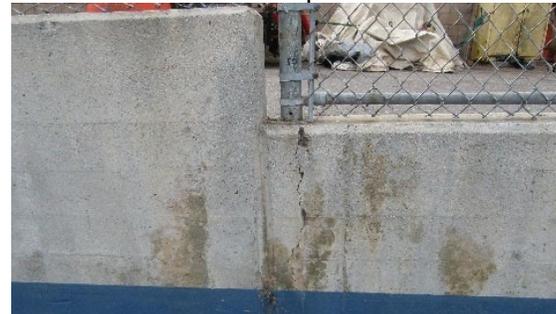
This project will repair and reconstruct distressed walls and court surfaces, including cosmetic repairs of surface cracking, throughout Recreation Park to improve safety, extend facility life, and maintain compliance with building standards.

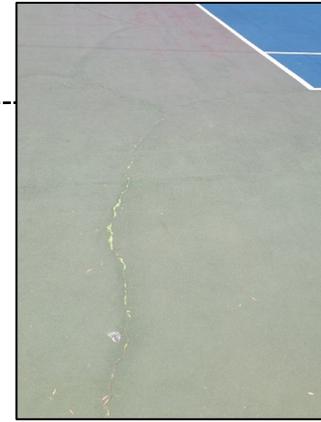
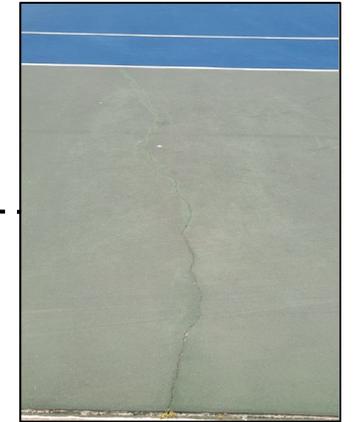
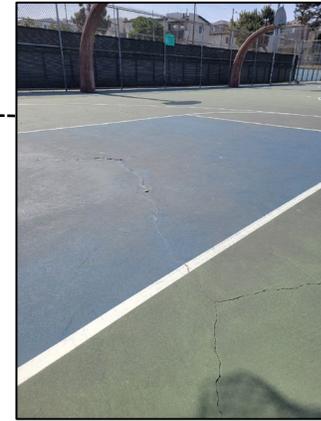
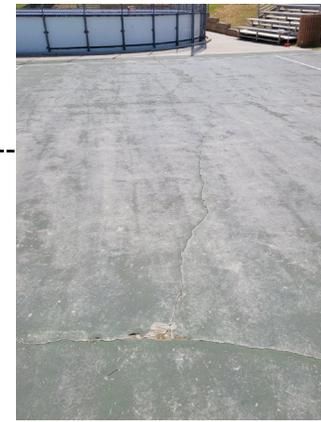
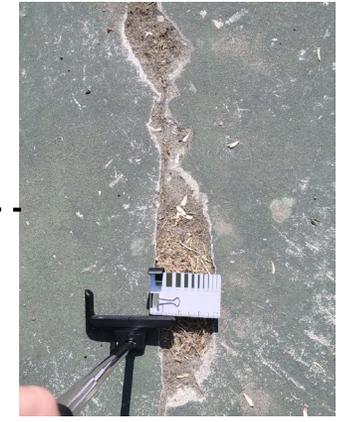
Court Crack Repair Procedure : Vertical & Horizontal Face

- i. Cracks let in water and weaken the concrete over time
 - i. Small cracks: sealed with liquid epoxy to bond concrete
 - ii. Larger cracks: cleaned and filled with stronger repair material
 - i. Methods:
 - i. Gravity fill (epoxy sinks in naturally)
 - ii. Flood coat (spread to seal many fine cracks)
 - iii. Injection (pump epoxy into deeper cracks)
 - ii. Goal: stop water intrusion, strengthen walls, and extend life of courts
